RE: Baruch College - Site "B"  
Contract #16 - GC #2  
Epoxy Terrazzo - Uplift/Debonding

## TESTWELL LABORATORIES, INC.

### PRELIMINARY SITE INVESTIGATION REPORT

Client:	TDX Construction Corp.	Lab #:	Pending
Project:	Baruch College - Site B	Report #:	ML-01
Address:	55 Lexington Avenue	Field Visit Date:	03/04/03
	New York, New York	Report Date:	03/05/03
Construction Type:	Terrazzo flooring system on concrete slab	Petrographer:	J. Walsh
		Page 1 of 10

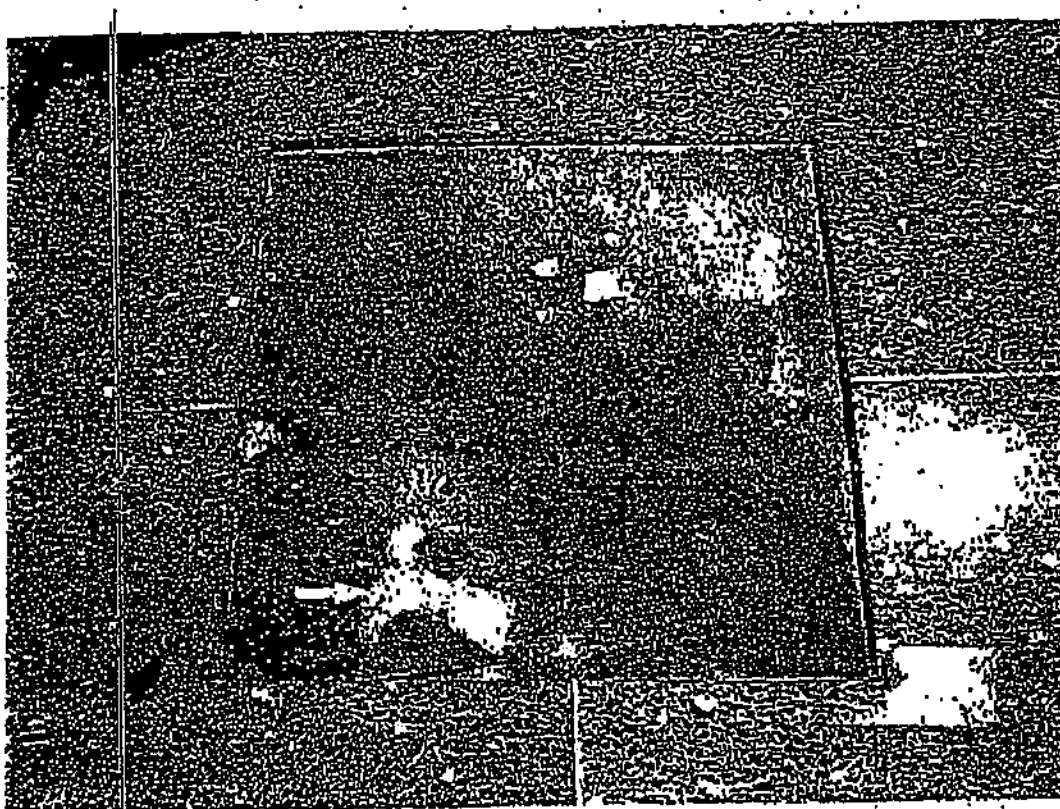
- 11) Some indication of failure between the slab and self-leveling flooring bond is noted. This is evidenced by clean separations at probe locations 7 and 12. Probe B-1 exposes a four corner contact. Sounding of the substrate revealed a debonding of the Conflow only below one corner of the four terrazzo segments. Samples of the debonded Conflow were recovered freshly from the substrate.

**Figure 5: Probe location B1. The epoxy membrane is completely debonded from the smooth self-leveling compound surface. In the lower left quadrant (arrow), the self-leveling compound is cleanly debonded from the concrete substrate. Sounding indicates that the debonding is present nearly everywhere below that one corner.**
